WASHINGTON STATE UNIVERSITY
LONG-RANGE HOUSING PLAN

PULLMAN, WASHINGTON

VOLUME 1

07 OCTOBER 2010

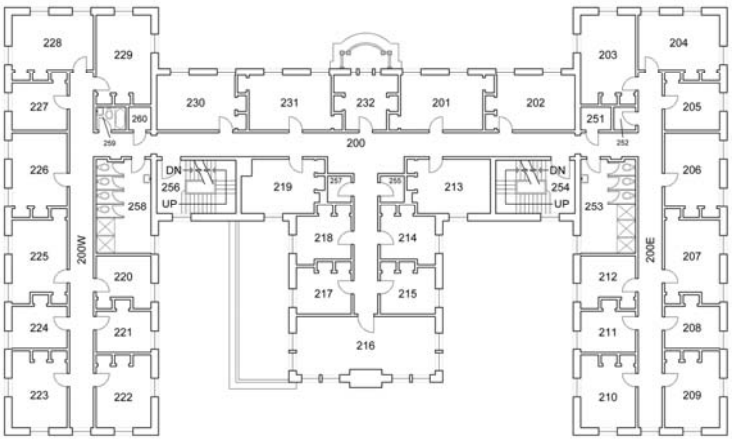
EXISTING TYPICAL / SIMILAR UPPER FLOOR PLAN (FLOORS 2-3): DUNCAN DUNN

The structural framing systems shows no signs of significant deterioration and remain adequate to support the gravity loads associated with current use.

- :: Slight deterioration and erosion of both brick and mortar is apparent throughout the building
- :: Structural conditions ranges from good to adequate throughout and appears to be well maintained for a building of its age and type
- :: Copper and bituminous roofs are in poor condition
- :: Chimney and cupola appear to be in poor condition

The type and severity of the seismic deficiencies found are typical for a building of this age and type.

- :: The bathroom fans and ductwork are in fair condition, but are installed in the occupied spaces and are unsightly
- :: Domestic water heater is in poor condition

Building test fit diagrams were completed for this facility, to assess potential capacity and amenities, and can be found in Volume 2, Appendix B.

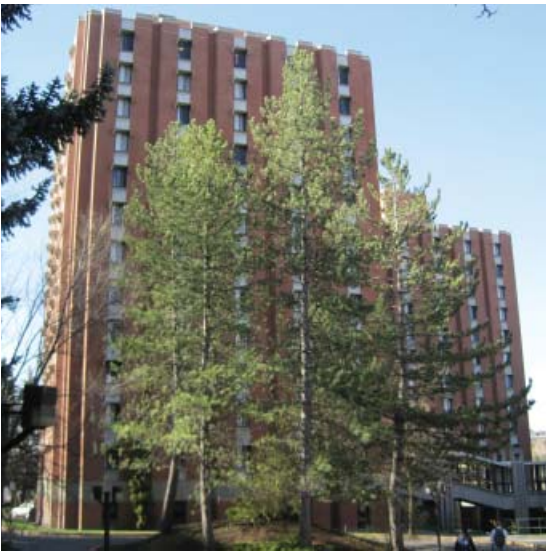
- The exterior building materials for the Stephenson complex is red brick masonry and concrete.
- :: Brick appears to be in fair condition
 - :: Concrete appears to be in fair condition
 - :: Isolated incidents of concrete “eyebrow” window shading devices failing
 - :: Stephenson East’s newer single-ply roof is in good condition, however re-used existing edge flashing is in poor condition
 - :: Stephenson South’s modified-bitumen torch-down roof is nearing the end of its serviceable life, according to the 2009 WSU Residential Building Roof Study

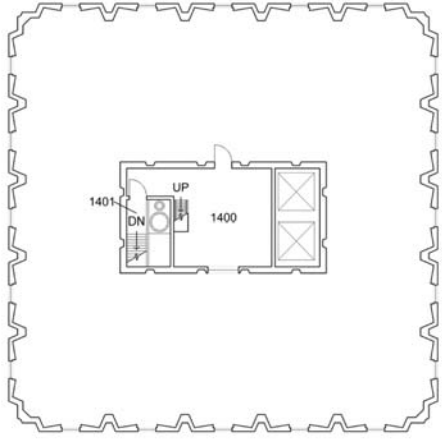
EXISTING 14TH FLOOR PLAN: STEPHENSON NORTH
(STEPHENSON SOUTH & EAST SIMILAR)

- :: Interior walls appear to be in good condition
- :: Interior paint appears to be in good condition
- :: Ceilings appear to be in fair condition
- :: Carpet appears to be in fair to good condition
- :: Vinyl composition tile (VCT) appears to be in fair condition
- :: Single-pane window system appear to be original to the building and have poor insulating values
- :: Window curtains and blinds appear to be in fair to good condition
- :: Doors and frames appear to be in good condition but do not have ADA compliant hardware
- :: Casework and built-in furnishings appear to be in good condition

The building is heated using steam converted to hot water and circulated through the building to hydronic radiators. There is no existing cooling system for the buildings. An active mechanical ventilation system is present in the residence hall.

- :: Plumbing fixtures appear to be in fair to good condition
- :: Light fixtures appear to be in fair to good condition

An automatic fire sprinkler and fire protection system is installed throughout the buildings. There is card-swipe access control to the residence halls. An elevator is located in each of the three Stephenson residence towers. Stephenson North and South each have a dedicated accessible unit.

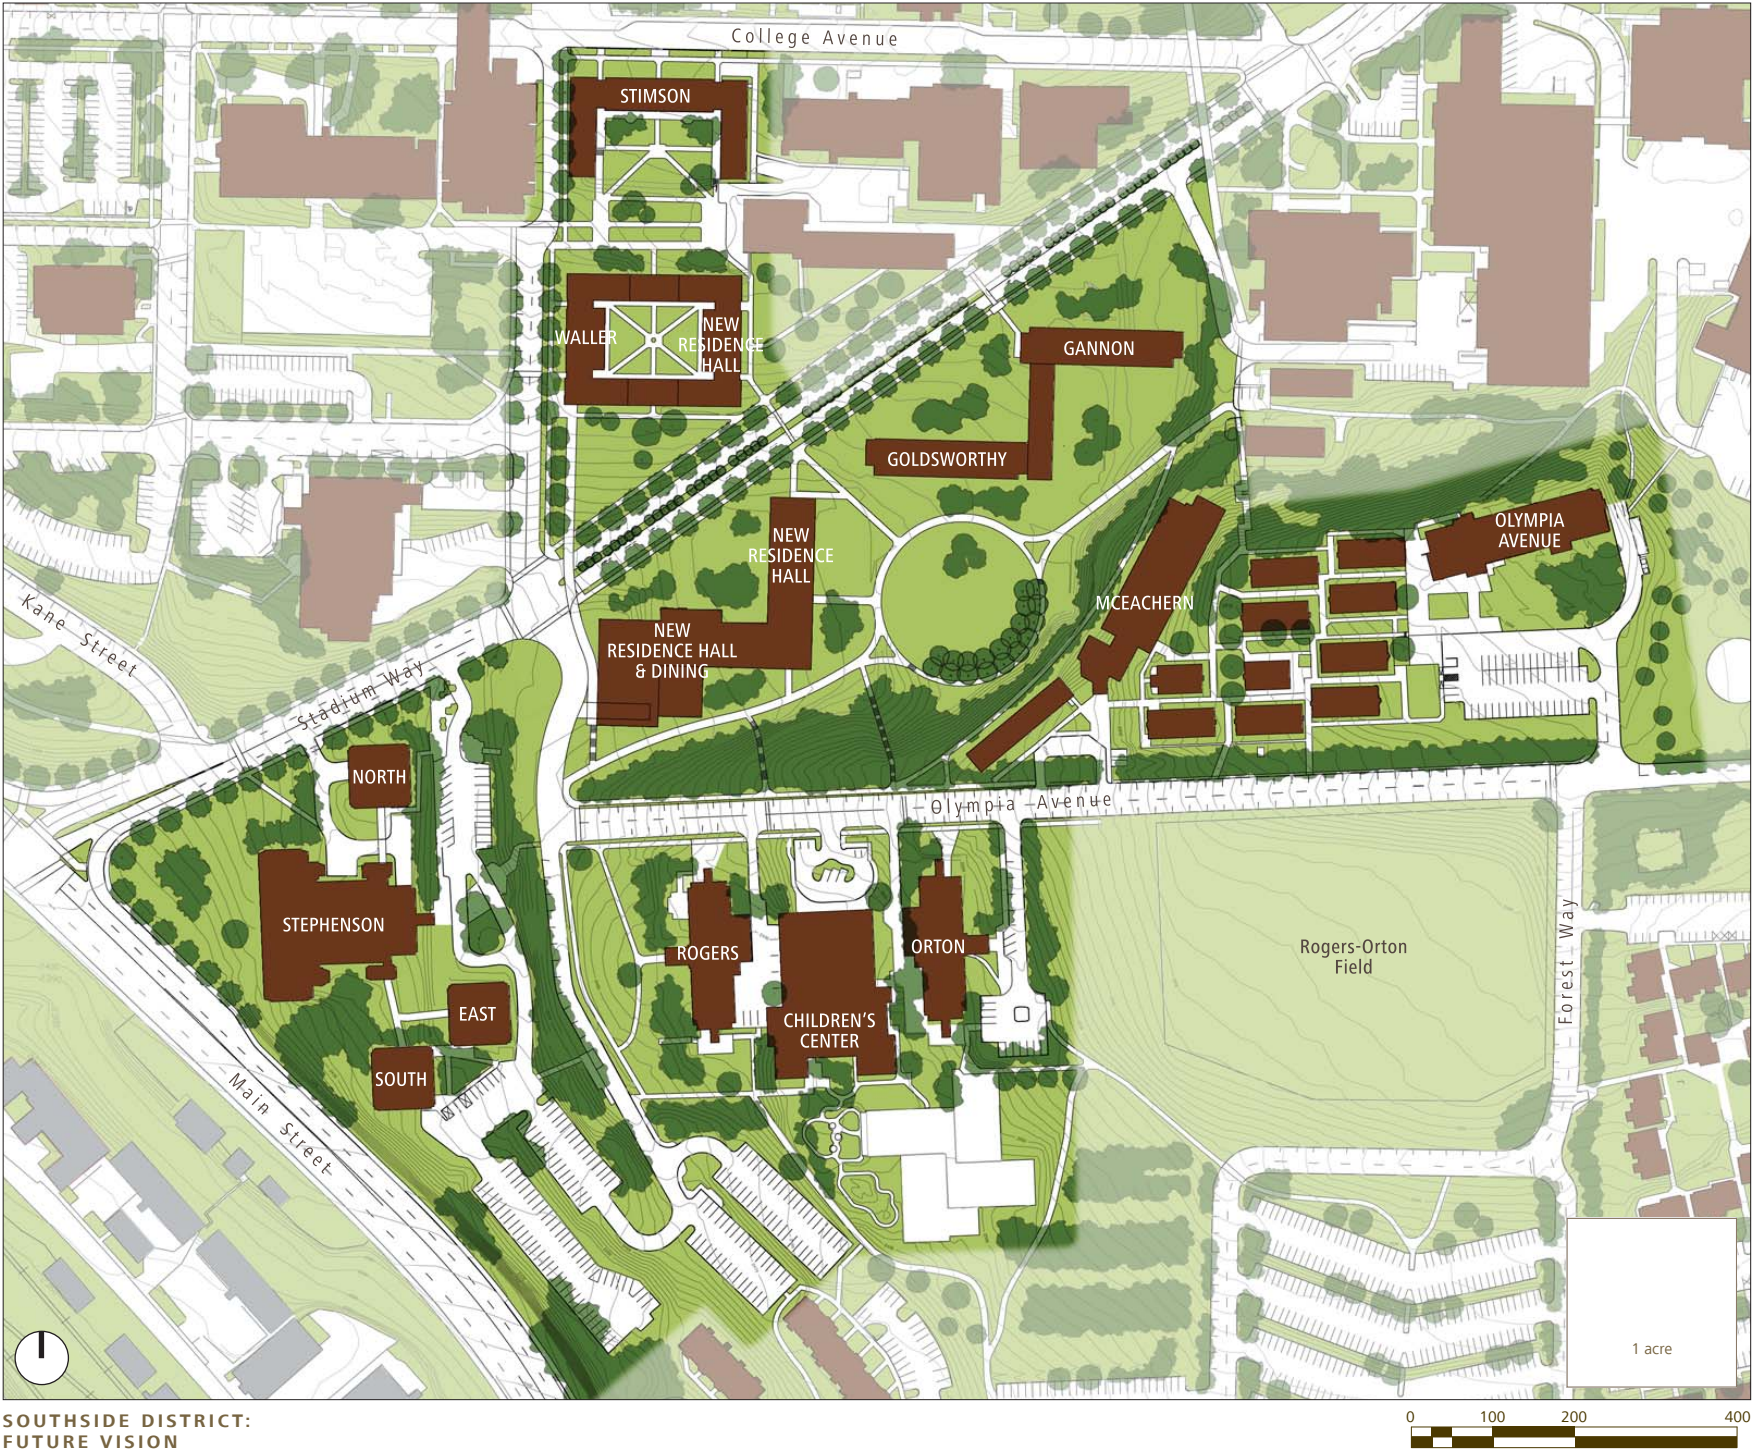
**SOUTHSIDE DISTRICT:
FUTURE VISION**

Along with the modernization and diversification of housing offerings contained within Gannon and Goldsworthy halls, and the replacement of Kruegel and McAllister with similarly diverse housing offerings, the future vision replaces parking and service areas with student-oriented open space.

This south-facing open space, located at the geographic center of the Southside District, is intended to serve as a key unifying element that connects surrounding residence halls to each other, further reinforcing and supporting the community of students who live there.

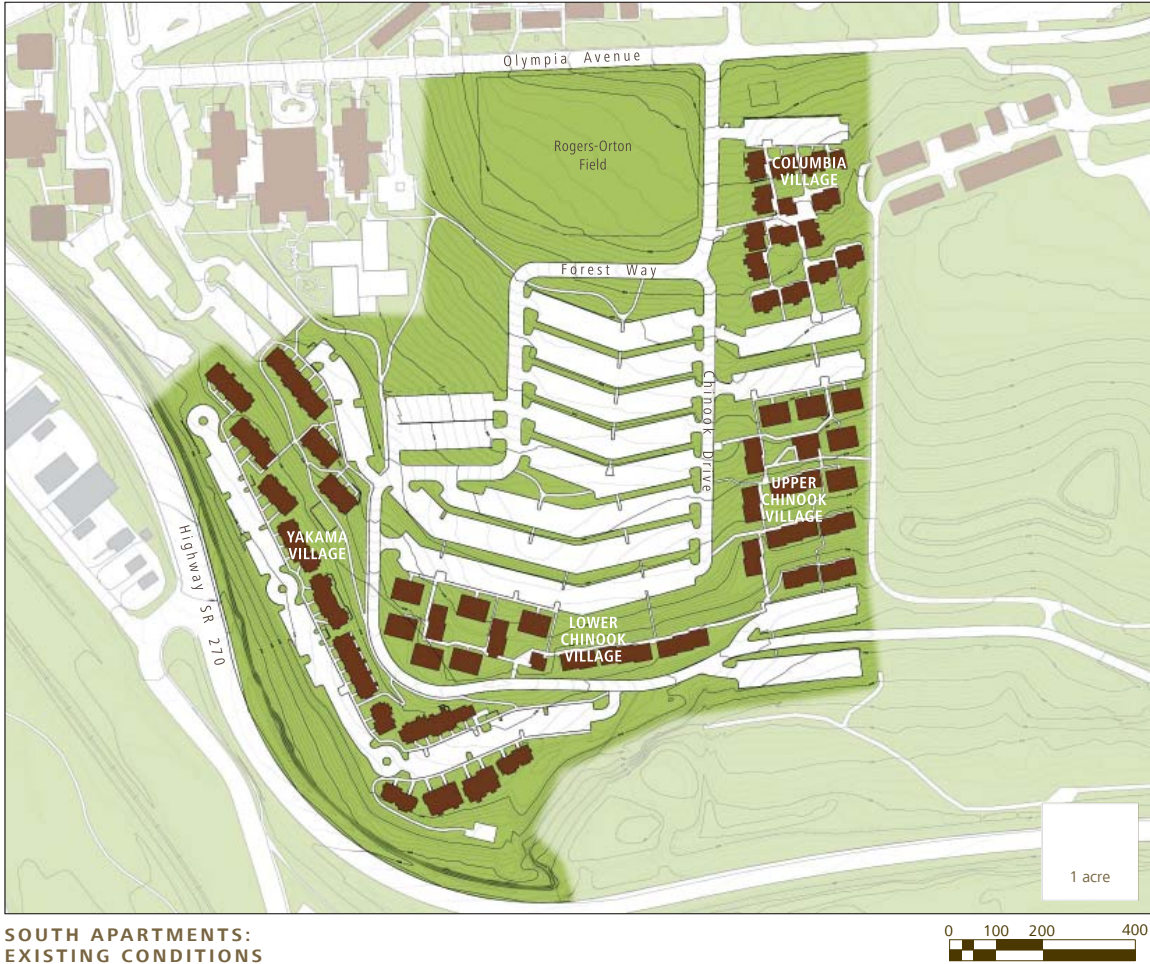
SOUTH APARTMENTS: EXISTING CONDITIONS

Existing campus buildings

Existing non-campus buildings

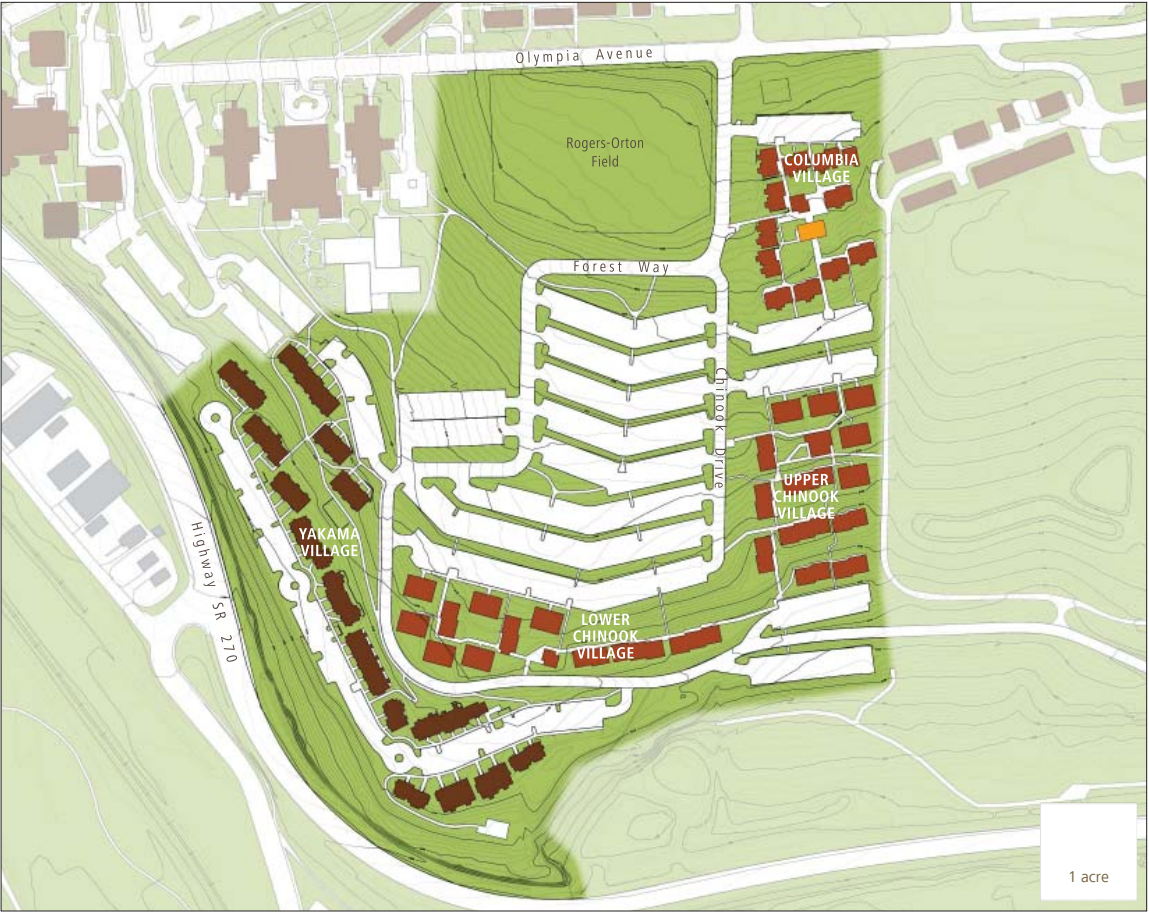
SOUTH APARTMENTS:
PROPOSED AND RECENTLY COMPLETED PROJECTS (2008 - 2027)

- New construction
- Renovation/modernization
- Refurbishment
- Existing campus buildings
- Existing non-campus buildings

Budget limitations have precluded the possibility for new units or full replacement units in the South Apartments. However, the long-range approach for the South Apartments will incorporate a new community center at Columbia Village, as well as a series of strategic modernization projects at each facility.

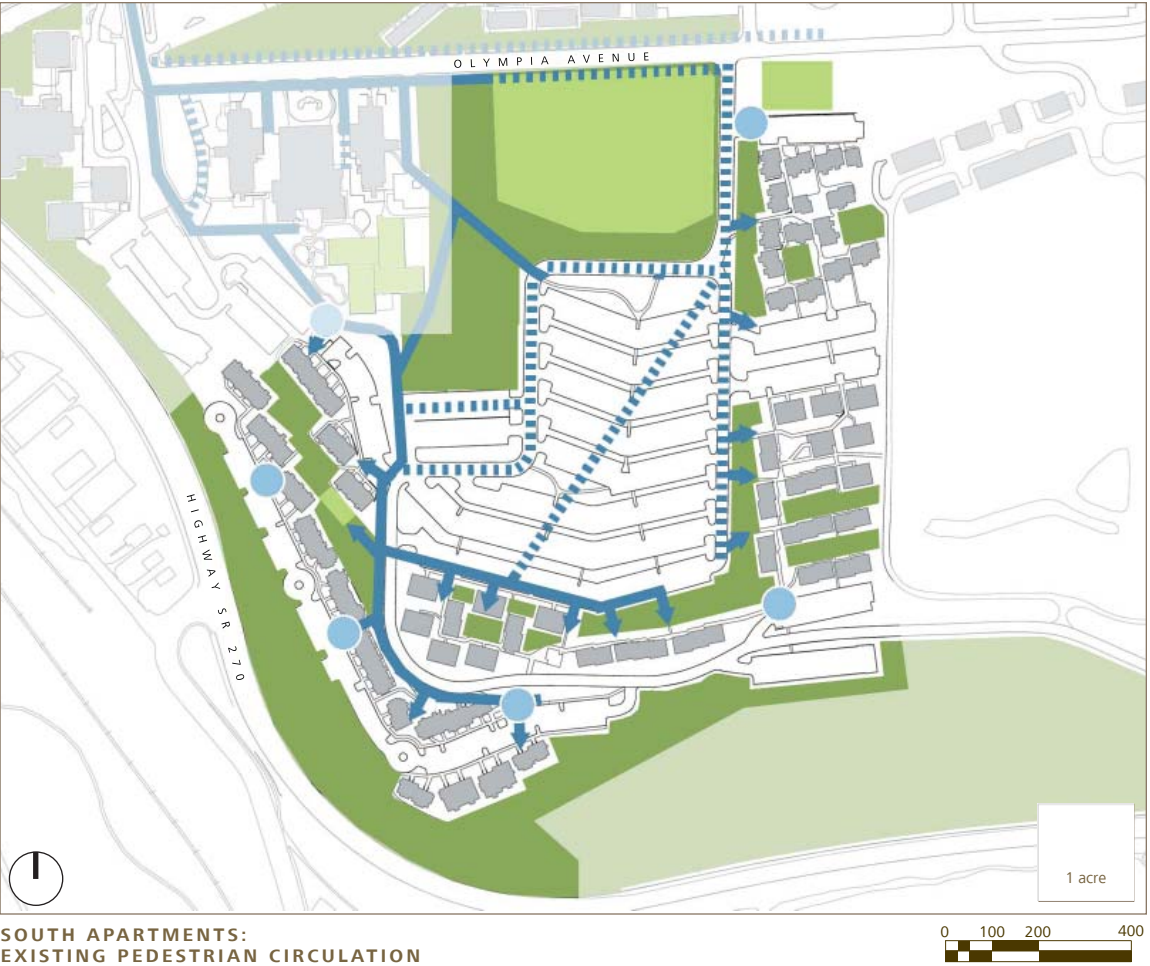
Pedestrian circulation
-   Pedestrian circulation through parking area
-   ADA accessible route
-   Programmed open space
-   Unprogrammed open space
-   Shuttle stops

PEDESTRIAN CIRCULATION AND OPEN SPACE
The South Apartments lack clarity in the pedestrian circulation system. Internally, each residential area has walks that connect parking to the residential units. Some of these pedestrian systems, such as are found in Columbia Village, remove the user from the parking environment while others, such as Yakama Village, are predominately oriented to the street-parking environment.

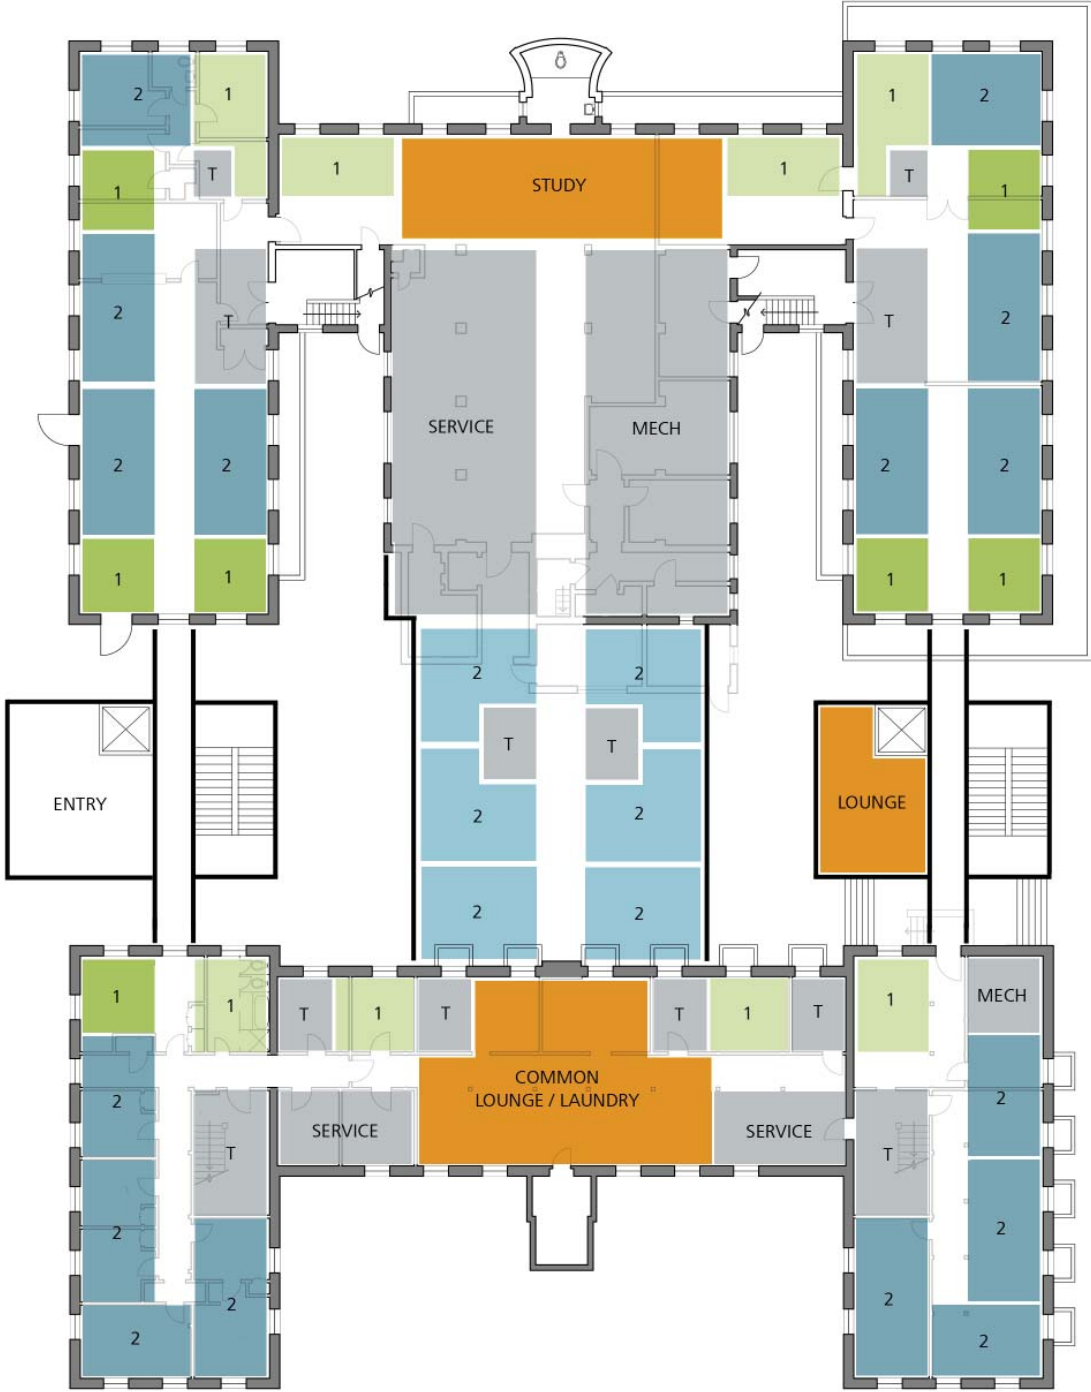
DUNCAN DUNN & COMMUNITY:
PRELIMINARY GROUND FLOOR TEST FIT

The existing parking lot to the west will be replaced by a new pedestrian-oriented green space. The existing buildings with their new connectors are intended to merge the past with the present, while moving WSU into the future.

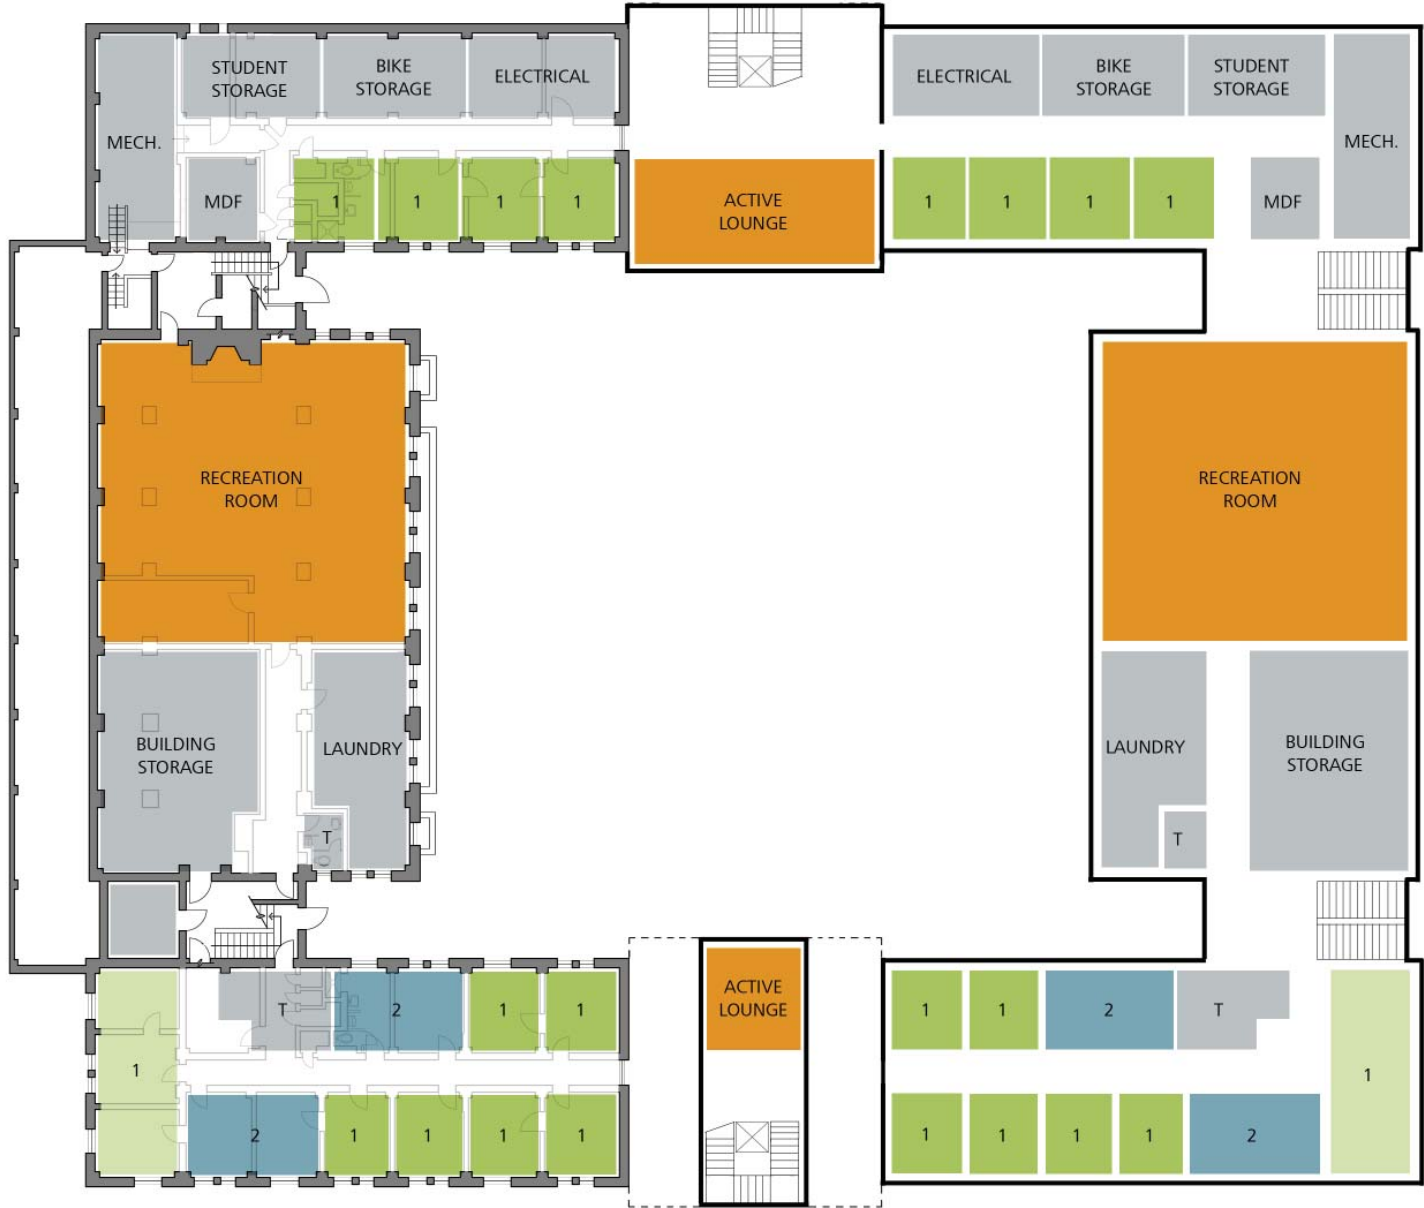
**WALLER AND WALLER II:
PRELIMINARY GROUND FLOOR TEST FIT**

Upon completion, Waller and Waller II will house approximately 300 beds in various room configurations designed to appeal to broader and more diverse student populations. Room configurations include standard single and double rooms that utilize shared community bathrooms, and suite-style single and double rooms, both of which include a bathroom within the unit.
